Manhole Inspection Summary

Manhole # S69W__007MH

Location Address: **1920 Portal St.**

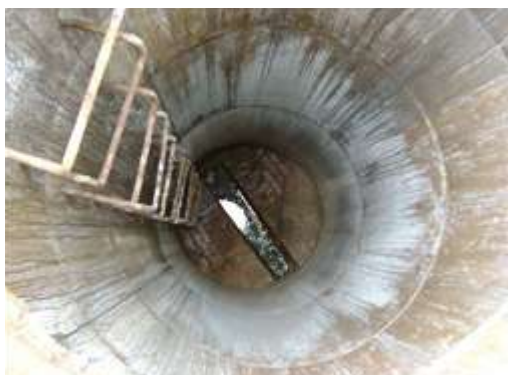
Defect 1

Condition: ☐ Sound ☐ Cracked ☐ Root Intrusion ☒ Loose Brick ☒ Deteriorated

Infiltration: ☐ None ☐ Joint ☐ Cracks ☒ Mortar ☐ Roots ☐ Wall

Infiltration coming from chimney

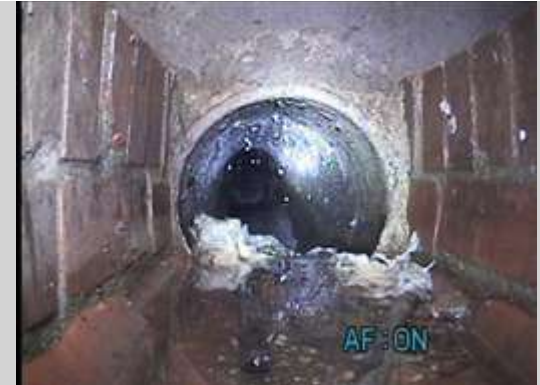
12 O'Clock Outflow

8 in. Circular Gravity Sewer
Pipe Out @ 12 O'Clock

Pipe Height: **8.4** (in.) Rod and Bar (Angled)
Pipe Material: **Clay** ☐ Pipe Lined
Invert Depth: **14.58** (ft.) Flow Characteristics: **Slow**
Deposits: ☒ None ☐ Mud ☐ Sludge ☐ Debris ☐ Grease
Silt Depth: (in.) Deposits Extent:
Infiltration: **None** Pipe Seal Cond: **Sound**

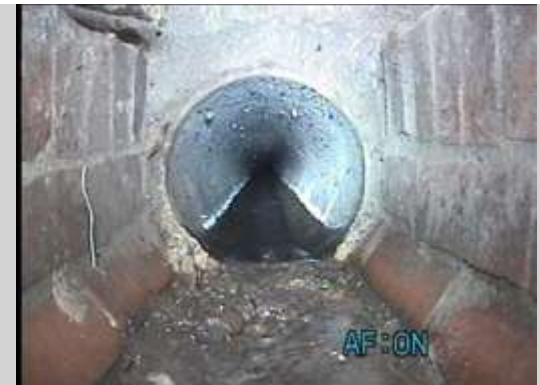
6 O'Clock Inflow

8 in. Circular Gravity Sewer
Pipe In @ 6 O'Clock

Pipe Height: **8.4** (in.) Rod and Bar (Angled)
Pipe Material: **Clay** ☐ Pipe Lined
Invert Depth: **14.50** (ft.) Flow Characteristics: **Slow**
Deposits: ☒ None ☐ Mud ☐ Sludge ☐ Debris ☐ Grease
Silt Depth: (in.) Deposits Extent:
Infiltration: **None** Pipe Seal Cond: **Sound**
